Grassed Waterway at Stroda's

Project Background

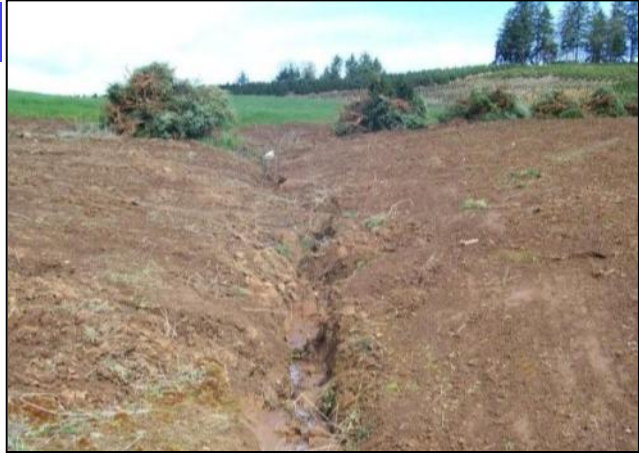
Pre-project: Photo shows bottom of drainage looking uphill. Note the lack of vegetation and deep gulying in the drainage channel.

For this project, landowner, with assistance from the Watershed Council, installed a grassed waterway that runs the length of the drainage. The bottom of the channel was widened, and a perforated flexible drain pipe surrounded with drain rock was installed sub-grade. These steep, eroding drainages are a common issue on Christmas tree farms. However, grassed waterways have been successfully installed on several tree farms in the Willamette Valley. In agricultural areas, grassed waterways act as vegetated filter strips that reduce erosion and filter nutrients before they drain into streams.

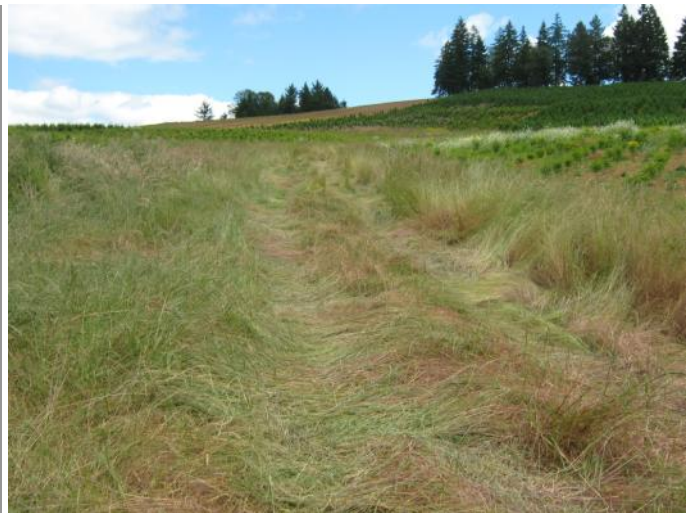
Post-project: Note the much gentler slopes in the drainage area and full vegetative cover. Grass establishment has been excellent.

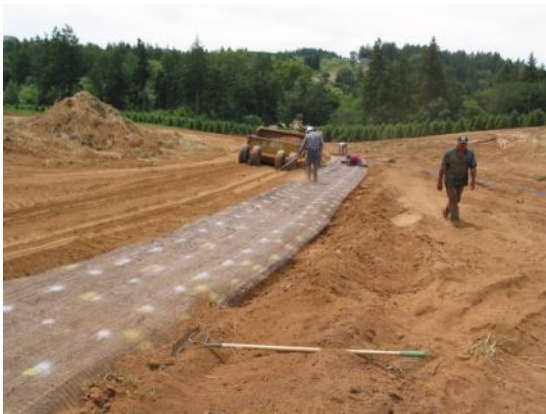
Implementation: The landowner uses a scraper and carry-all to construct the grassed waterway.

- ◆ The existing channel bed was re-graded and widened using a carry-all and scraper (see photo) to an even 10-foot average surface, allowing water to flow uniformly.
- ◆ The channel banks were graded to blend in with the adjacent slope.
- ◆ Once earthwork was complete, the Strodas seeded the bare soil with grass covered and covered it with erosion control fabric. The grass grows up through the fabric, forming a strong, erosion-resistant sod-fabric matrix.
- ◆ Long-term maintenance consists of annual mowing.

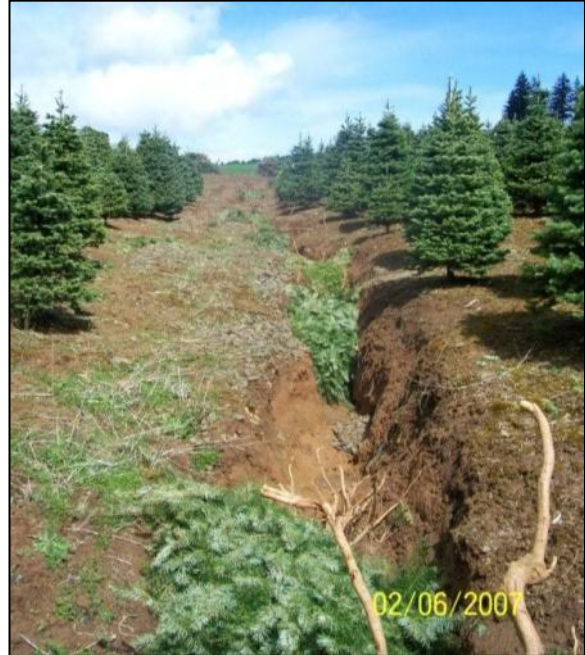
Pre-project: Bottom of drainage. Erosion was 3 – 4' deep here. Landowner put wood (i.e. Christmas trees) and small rocks in drainage in an attempt to decrease erosion with limited success.

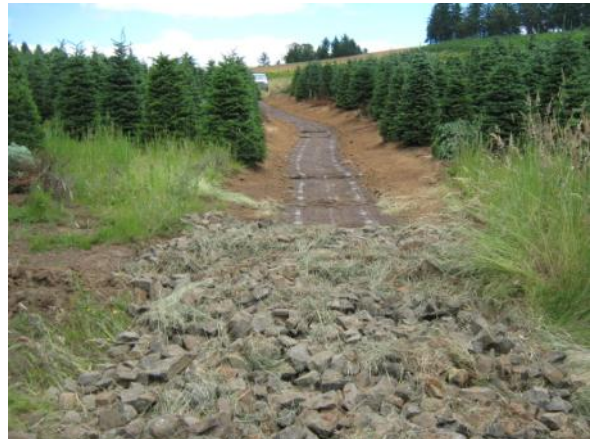
Post-project: view from bottom of drainage looking uphill. This shows the last constructed portion of the grassed waterway, that was completed in June 2010. The bottom of the drainage has a small rock pad that dissipates energy from the sub-surface drain pipe that day lights here.
