**Water Quality Results for the Middle and Coast Fork
Willamette Watersheds and Eight Small Cities in the Upper
Willamette Sub-basin: 2008- 2010**

**Middle Fork Willamette Watershed Council
Coast Fork Willamette Watershed Council
Long Tom Watershed Council
Aryana Ferguson, Madrona Consulting**

July 2011

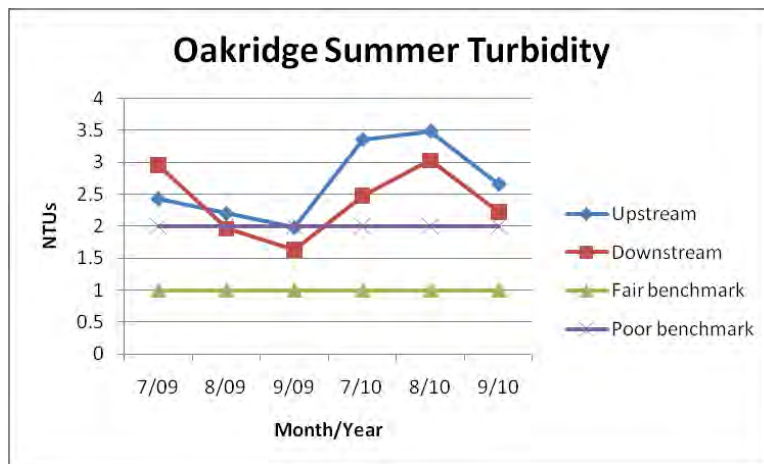
Figure 6. Oakridge Middle Fork summer turbidity.

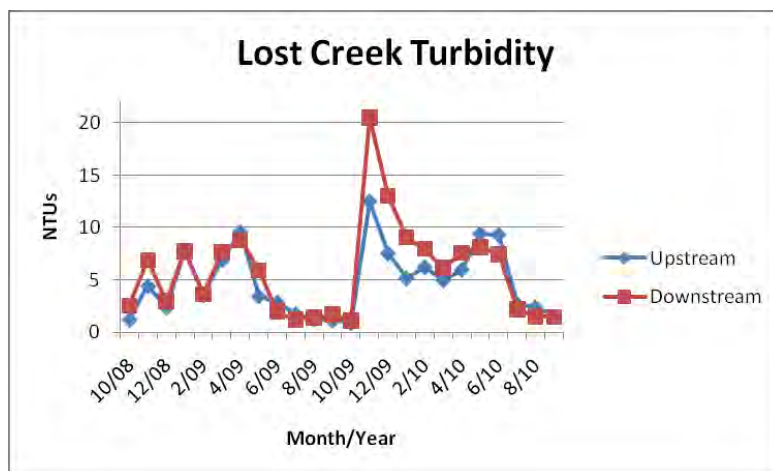
Figure 29: Lost Creek up and downstream turbidity.

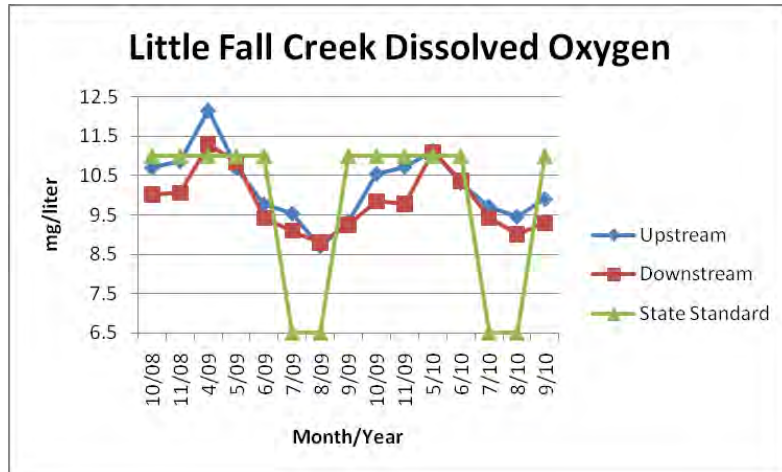
Figure 31. Dissolved oxygen for Little Fall Creek.

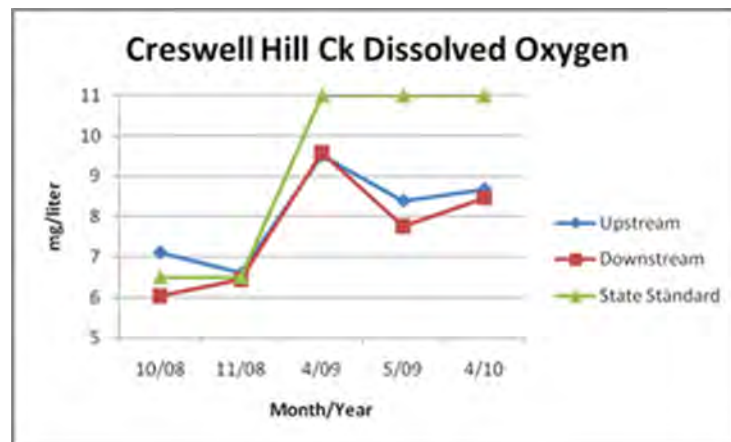
Figure 42. Dissolved oxygen for Creswell Hill Creek.
