GRASSED WATERWAY AT STRODA BROTHERS FARM

PROJECT BACKGROUND

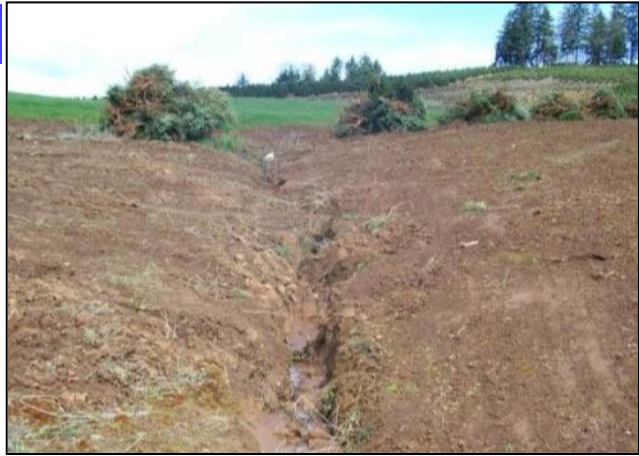
Pre-project: Photo shows bottom of drainage looking uphill. Note the lack of vegetation and deep gulying in the drainage channel.

For this project, landowner, with assistance from the Watershed Council, installed a grassed waterway that runs the length of the drainage. The bottom of the channel was widened, and a perforated flexible drain pipe surrounded with drain rock was installed sub-grade. These steep, eroding drainages are a common issue on Christmas tree farms. However, grassed waterways have been successfully installed on several tree farms in the Willamette Valley. In agricultural areas, grassed waterways act as vegetated filter strips that reduce erosion and filter nutrients before they drain into streams.

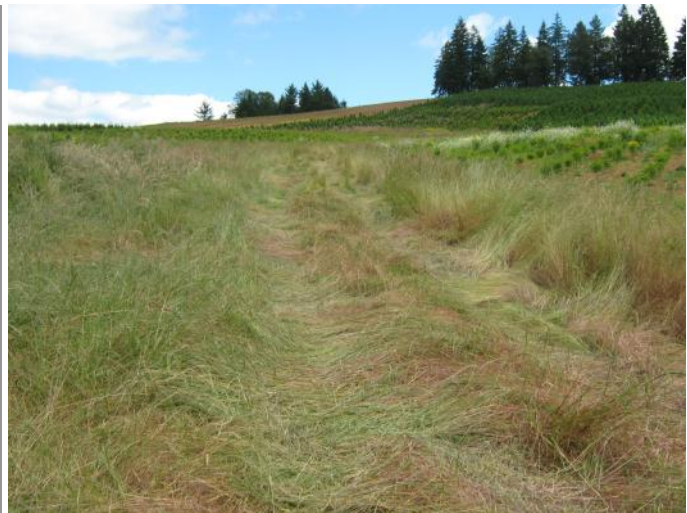
Post-project: Note the much gentler slopes in the drainage area and full vegetative cover. Grass establishment has been excellent.

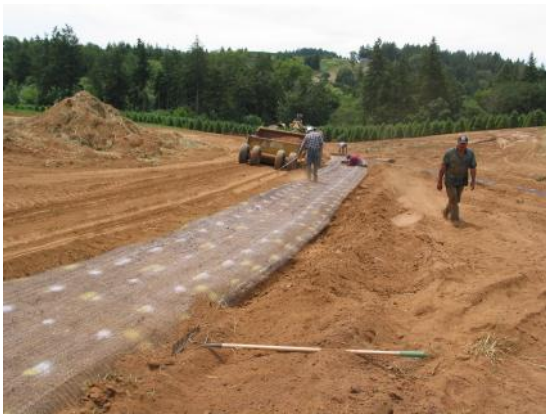
Implementation: The landowner uses a scraper and carry-all to construct the grassed waterway.

- ◆ The existing channel bed was re-graded and widened using a carry-all and scraper (see photo) to an even 10-foot average surface, allowing water to flow uniformly.
- ◆ The channel banks were graded to blend in with the adjacent slope.
- ◆ Once earthwork was complete, the Strodas seeded the bare soil with grass and covered it with erosion control fabric. The grass grows up through the fabric, forming a strong, erosion-resistant sod-fabric matrix.
- ◆ Long-term maintenance consists of annual mowing.

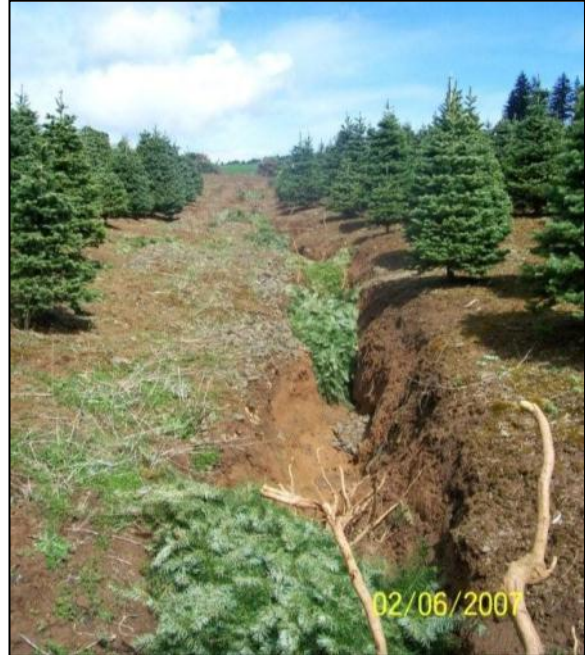
Pre-project: Bottom of drainage. Erosion was 3 – 4' deep here. Landowner put wood (i.e. Christmas trees) and small rocks in drainage in an attempt to decrease erosion with limited success.

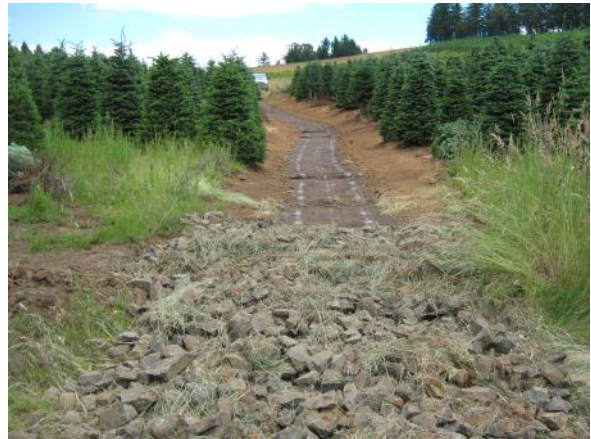
Post-project: view from bottom of drainage looking uphill. This shows the last constructed portion of the grassed waterway, that was completed in June 2010. The bottom of the drainage has a small rock pad that dissipates energy from the sub-surface drain pipe that day lights here.
